Flood Control Project Maintenance
2020 Structure Summary Report
Overall Unit and Item Ratings

Plumas County

North Fork Feather River Diversion Channel Drop Structure No. 1

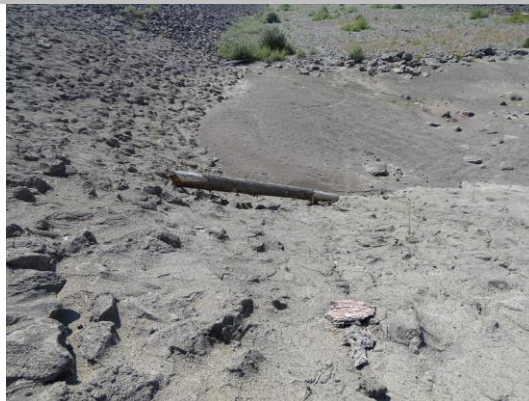
Photo 1 of 1 : ST_2020_NA0015_57_5_20200727_00007.jpg

View looking downstream of a log that needs to be removed, 2020.

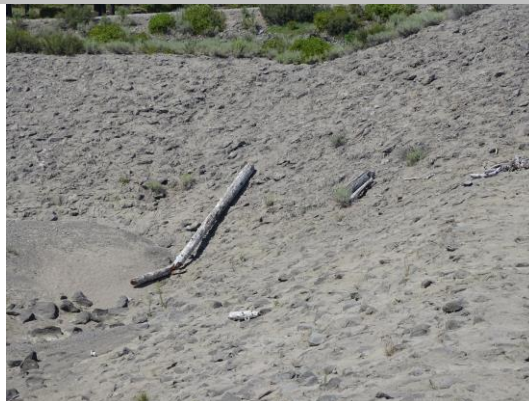
Photo 1 of 1 : ST_2020_NA0015_58_5_20200728_00006.jpg

View looking from left bank across the drop structure at a log that needs to be removed, 2020.

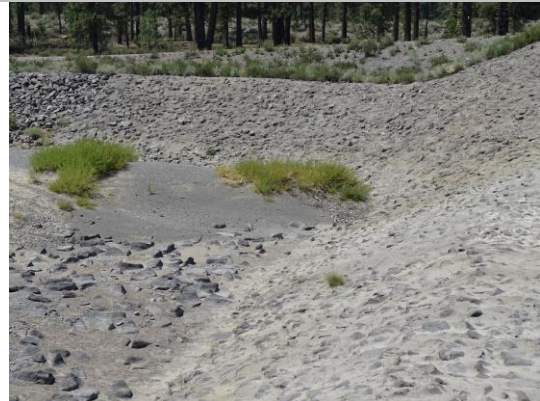
Photo 1 of 1 : ST_2020_NA0015_62_2_20200728_00008.jpg

View of the minimal sedimentation that is building up on left and right banks, the flow is not impeded, 2020.

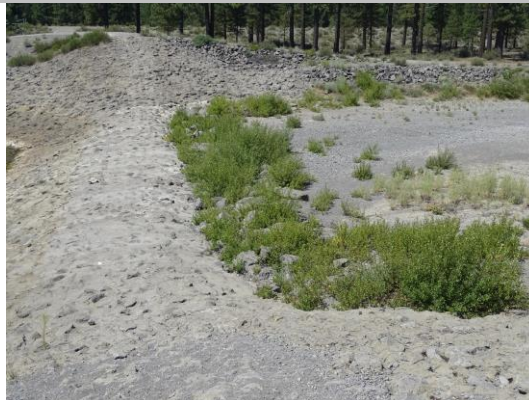
Photo 1 of 1 : ST_2020_NA0015_63_1_20200728_00008.jpg

LM Start	0.00	Rating **	A	Issue No.	1	
LM End	0.00	Issue Type +	Ma	Location *		
Category	Structures & Concrete Lined Channels			GPS Latitude/Longitude		
				Start		End
Item	Vegetation & Obstructions			40.272544 °	40.272544 °	
				-121.246161 °	-121.246161 °	
DWR ID	DWR_NA0015_63_t_2012_1					
Action/Comments						
Inspector Comments: Vegetation is not impeding flows.

Vegetation in channel near structure should be removed however it currently is not impeding flows, 2020.

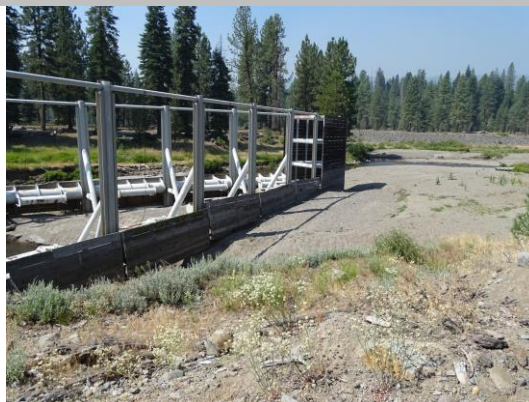
Photo 1 of 2 : ST_2020_NA0015_37_2_20200728_00029.jpg

View of the inlet structure and how the sedimentation builds up in front of the structure, 2020.

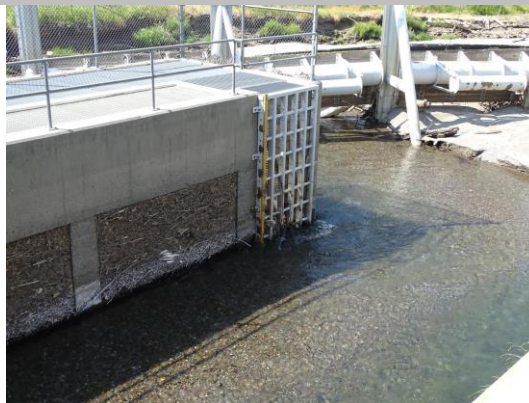
Photo 2 of 2 : ST_2020_NA0015_37_2_20200728_00030.jpg

View of the build up of sedimentation and debris at the fish ladder intake, 2020.

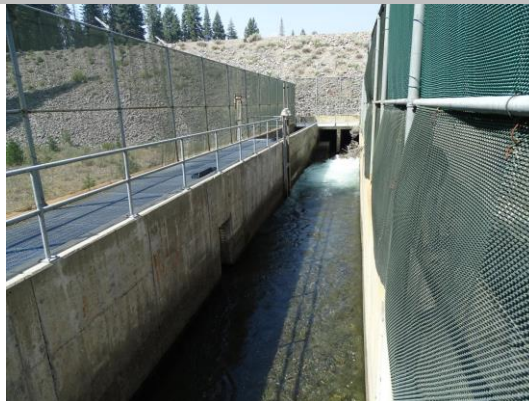
Photo 1 of 1 : ST_2020_NA0015_37_6_20200804_00044.jpg

View of the outlet box culverts, 2020.

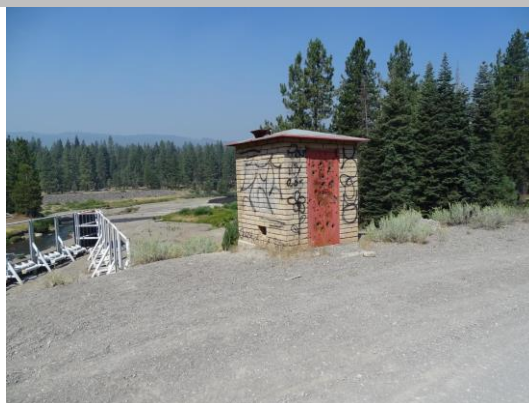
Photo 1 of 1 : ST_2020_NA0015_37_12_20200728_00028.jpg

Gauging house on top of dam, no longer used due to vandalism, 2020.

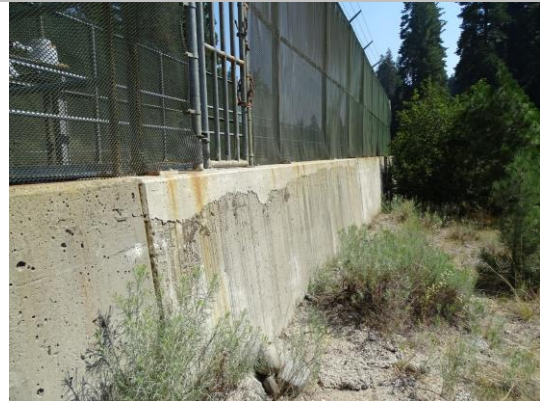
Photo 1 of 1 : ST_2020_NA0015_37_14_20200804_00038.jpg

View of the concrete spalling repair on the south wall of the outfall structure, 2020.
